Snyder v. Bass Pro Outdoor World, LLC. Engineering Investigation

George M. Saunders, Jr., P.E., C.F.E.I.
Mechanical Engineer

Project No.: S15-016

June 7, 2017

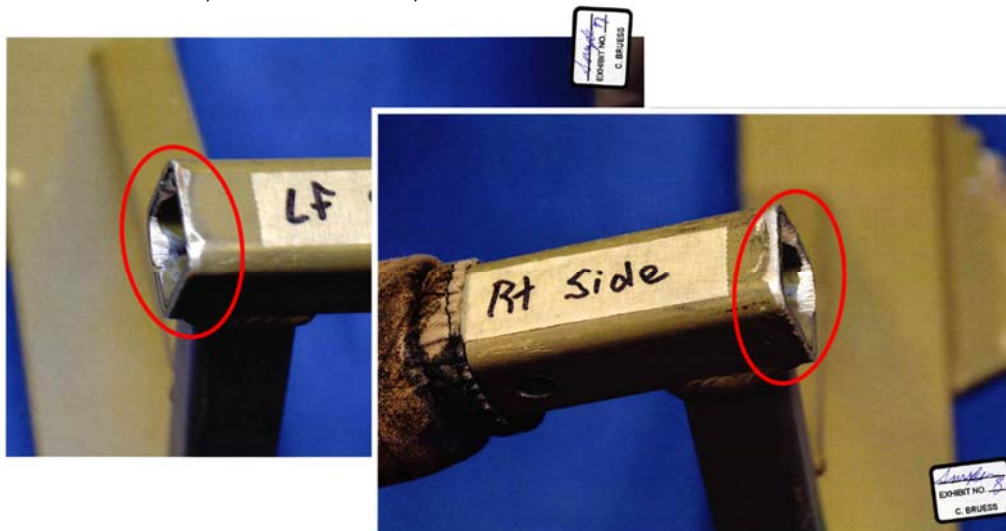
Figure 1 - Exhibits 7 and 8

Q. So, if you saw the, uh, the damage we see in Exhibit 7, would that have been something that would have caused you not to use the stand (indicating)?

Q. Was that also the type of damage [Exhibit 8] that you would look for when you were inspecting the stand?

10. Mr. Snyder's practice of not replacing the chain on his treestand was misuse of the treestand and directly contributed to Mr. Snyder's incident.
11. The accident resulted directly from misuse. Metal to metal contact between the steel link plates and the inner walls of the aluminum tubing under load was the direct cause of the wear pattern illustrated in Figures 1 and 10.

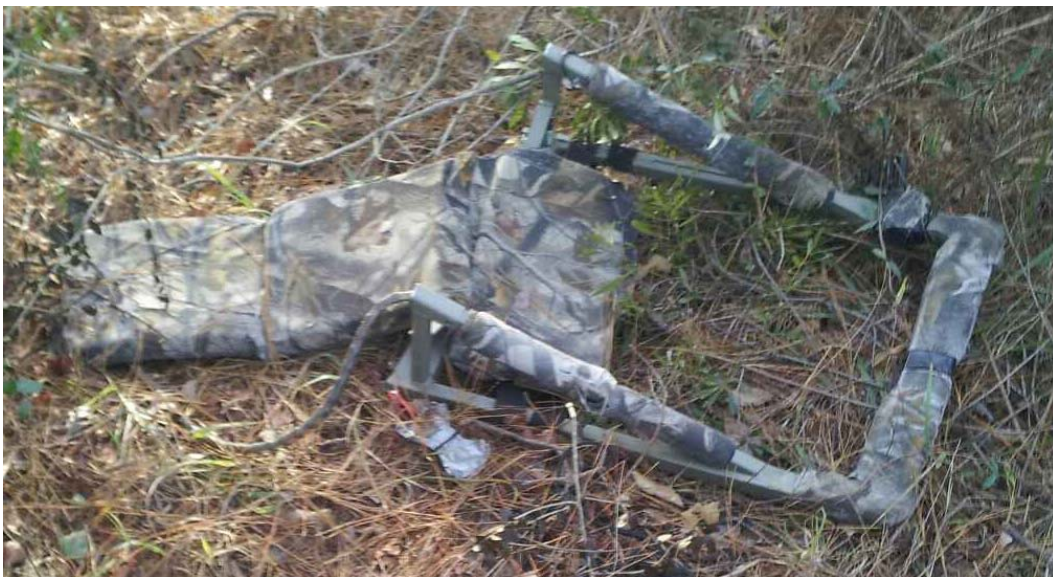
Figure 6 - Crop of photograph “20131129_152732.jpg”

- Figure 6 appear to be the earliest photograph of the treestand seat platform post-incident.
- This photograph and the remainder disclosed in folder P004238 show that the treestand had been modified from its post-incident condition. Referenced facing the tree, the left retaining pin has been removed and the longer length of chain is simply resting in the platform unrestrained. The right pin is in place but the short length of chain had been removed from the treestand prior to documentation.

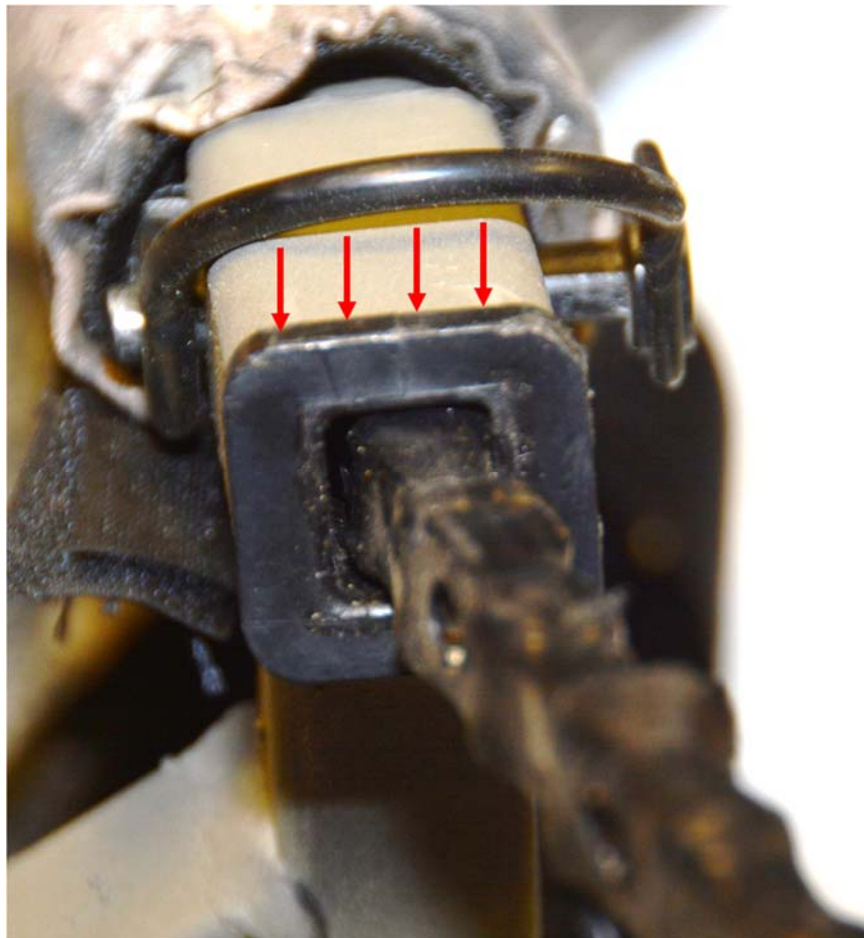
Figure 7 - Polymer Chain Guide - (Crop of Photograph 516)

The exemplar used API brand treestand (Grand Slam Bowhunter model GS2400, marked 'Olson') appeared to be consistent with a product illustrated in the 1999 catalog marked BPR000851 (as well as several others) based on the camouflage pattern on the seat, the color of the chain sheath material, the overall configuration, and the means of attachment of the foot platform foot straps. The on-product label only makes reference to API Outdoors, an indication that the product was manufactured prior to the involvement of Outland Sports, Inc (Photograph 521). It was significant to note that four polymer chain guides were present on this treestand (although the right guide on the foot platform needed to be replaced). The typical configuration is illustrated in Figure 7, not the reduced clearance between the chain the guide.

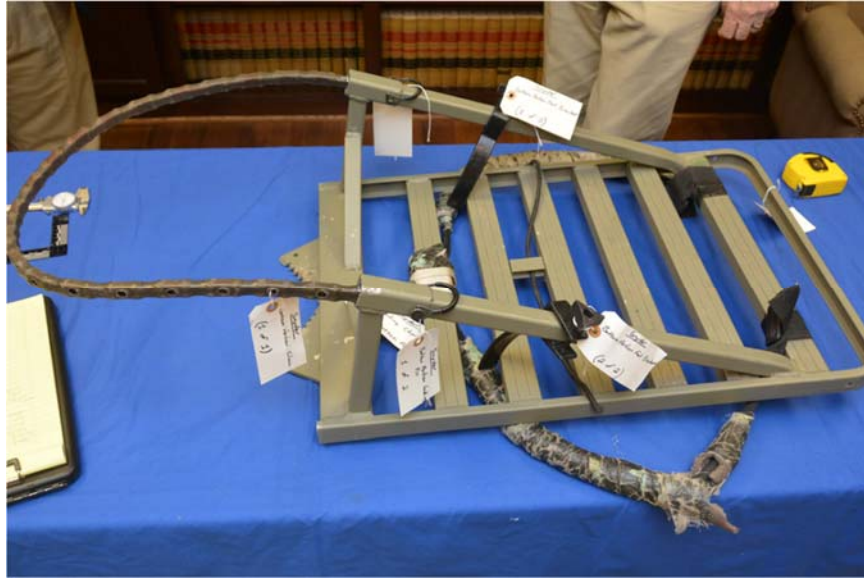
Figure 9 - Photograph 37

It was observed that the chains from Mr. Snyder's treestand had increased tolerance associated with the chain assembly when compared with a new chain assembly, as discussed further below.

Although the comparison is limited because the new chain was made from an entirely different manufacturer, tolerance measurements were taken of a new chain assembly. These chains showed that over a length of 18 inches the tolerance within the chain would allow 4 to 5 degrees of rotation. When 18 inches of Mr. Snyder’s chain was evaluated it allowed approximately 25 to 30 degrees of rotation or 6 times that observed in the new chain assembly. This is an indication of the increased flexibility caused by Mr. Snyder’s extended misuse of the chain assembly for well beyond the recommended service life. An increase in flexibility of the chain due to normal wear and tear would be expected, as stated by Dr. Clarke in his prior article. The increase in flexibility observed in Mr. Snyder’s chain was the direct result of long term misuse/abuse by Mr. Snyder.

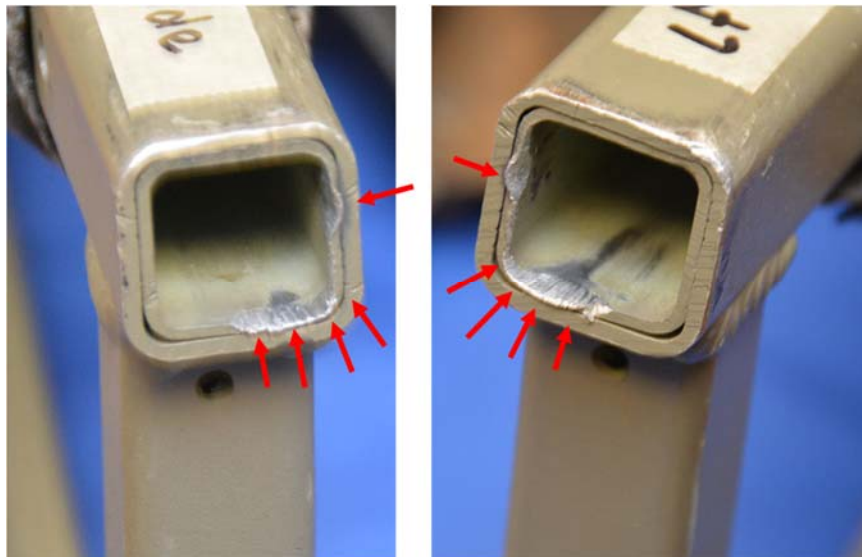
Figure 10 - Composite Image - Photographs 151 and 154

A unique wear pattern was observed at the location where the chain exited the treestand platforms, as illustrated in Figure 10. The wear pattern was due to metal to metal contact between the structural tubing of the treestand and the link plates on the chain, as discussed further below.

The wear-through of the chain jacketing combined with not maintaining the polymer chain guide eventually allowed direct metal to metal contact between the chain link plates and the inner walls of the aluminum structural tubing. *Metal to metal contact between the steel link plates and the inner walls of the aluminum tubing under load was the direct cause of the wear pattern illustrated in Figures 1 and 10.* When the chain assembly is not loaded during normal use it would sag to the condition illustrated in Figure 9. When viewed in cross-section on the right side of the treestand looking away from the tree, this condition would be approximated by the left image of Figure 12. When the chain was loaded from the rest condition, illustrated in the left image of Figure 12, point contacts would develop between the steel link plates and the inner walls of the aluminum tubing, resulting in material removal from the inner wall of the aluminum tubing (i.e. wear/gouging/galling). When the chain assembly is loaded it rotated toward the orientation illustrated in the right image of Figure 12 (looking away from the tree a counter-clockwise movement on the left and the clockwise movement on the right). The rotational motion of the chain combined with the mechanical resistance from the link to wall interaction would tend to pry the lower link plates from the chain assembly and compress the upper link plates into the chain assembly. *The sequence of events that developed over the course of years and lead to the separation of the chain at the time of Mr. Snyder's incident initiated with not using the polymer chain guides (an observable condition), progressed to the wear-through of the chain jacketing (an observable condition), continued with the ever increasing removal of material from the aluminum tubing (an observable wear pattern), to separation of one set of link plates (a stable condition per Dr. Clarke's prior article and an observable condition), and finally leading to ultimate separation on the day of Mr. Snyder's incident. The separation of the chain assembly at the time of Mr. Snyder's incident was not a one-time sudden event but the culmination long term misuse/abuse of the product, a series of unforeseeable consequences of a user not complying with written warnings and instructions, and a user ignoring obvious physical changes in the product over a period of years.* Mr. Snyder himself admitted that the damage at the end of the aluminum tubing was indicative of a condition that would have

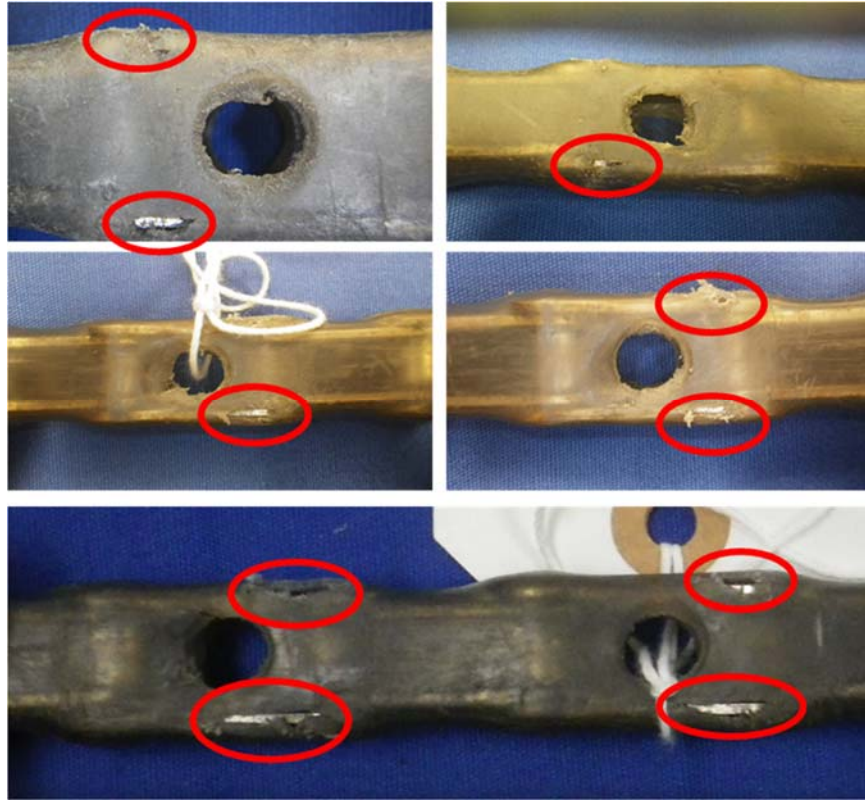
Figure 11 - Composite Image from Photograph 353, 356, 432, 435, and 466

The link plates of the chain are only exposed after the polymer jacketing material wore completely through, as illustrated in Figures 11 and 12.

It was observed that the jacketing material on the chain had worn through at several locations such that the steel link plates of the chain were no longer concealed/protected, as illustrated in Figure 11. This wear-through was also seen at the separation location. The wear-through locations were adjacent to the retaining pin holes and were consistently on one side of the chain assembly (the inside or tree side as installed). The consistency of the wear-through on the jacketing is an indication that it was Mr. Snyder's practice to leave the chain in the treestand when not in use and to only disconnect a single pin to connect the treestand to the tree for each use. The positioning of the chain in the structural tubing would only change relative to the size tree being used and by the increment of the pin hole spacing in the chain assembly. Because Mr. Snyder did not maintain the polymer chain guide (a low friction bearing surface) the chain jacket was pinched directly between the steel link plates and the corner of the structural tubing (a high friction and potentially abrasive bearing surface). *The wear-through of the chain assembly jacketing was the direct result of Mr. Snyder failing to maintain his treestand in the condition in which it was designed and sold by not maintaining and continuing to use the polymer chain guides which directly contributed to Mr. Snyder's incident.*
